# Guam Waterworks Authority (VP0989)

## CWA Collection System

Tumon, Guam

NEIC Field Investigation Photographs  
April 24 through May 4

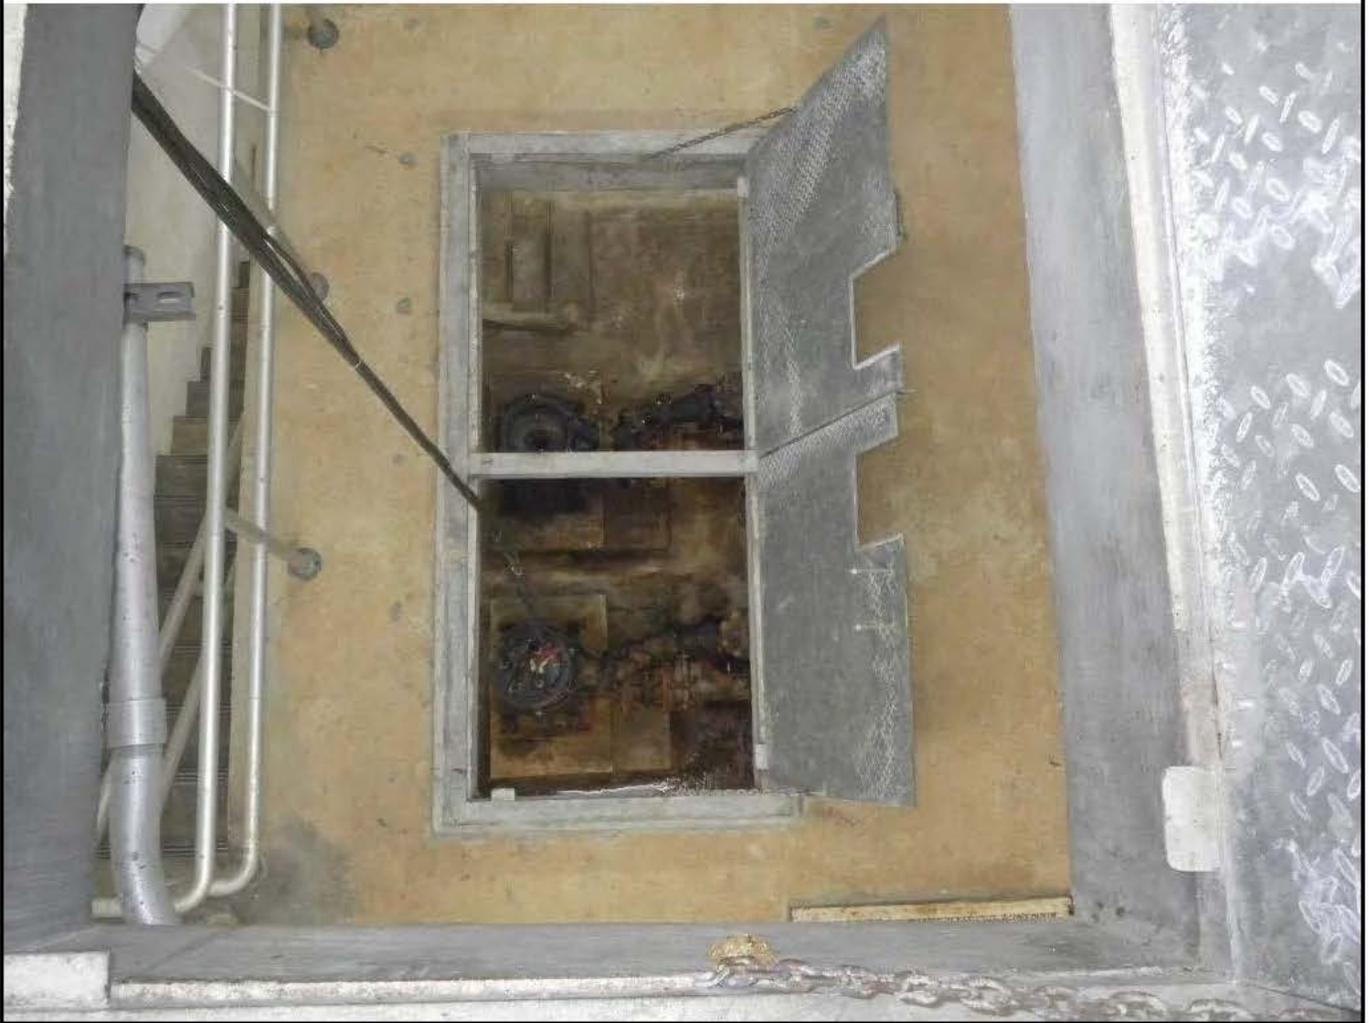
File Name: RIMG0142.JPG

Title	Guam Waterworks Authority (VP0989)
Subject	CWA Collection System
Date Time Stamp	5/3/2012 10:46:18 AM
Photographer	D. Vanlerberghe
Description	Talafofo pump station pump gallery, showing one pump out of two out for repair.
